Watts Bar Nuclear Plant, Unit 1  
Facility Operating License No. NPF-90  
NRC Docket Nos. 50-390

Subject: **Licensee Event Report 50-390/2013-004 Supplement 1**

Plant Trip on 500kV Transmission Line Fault

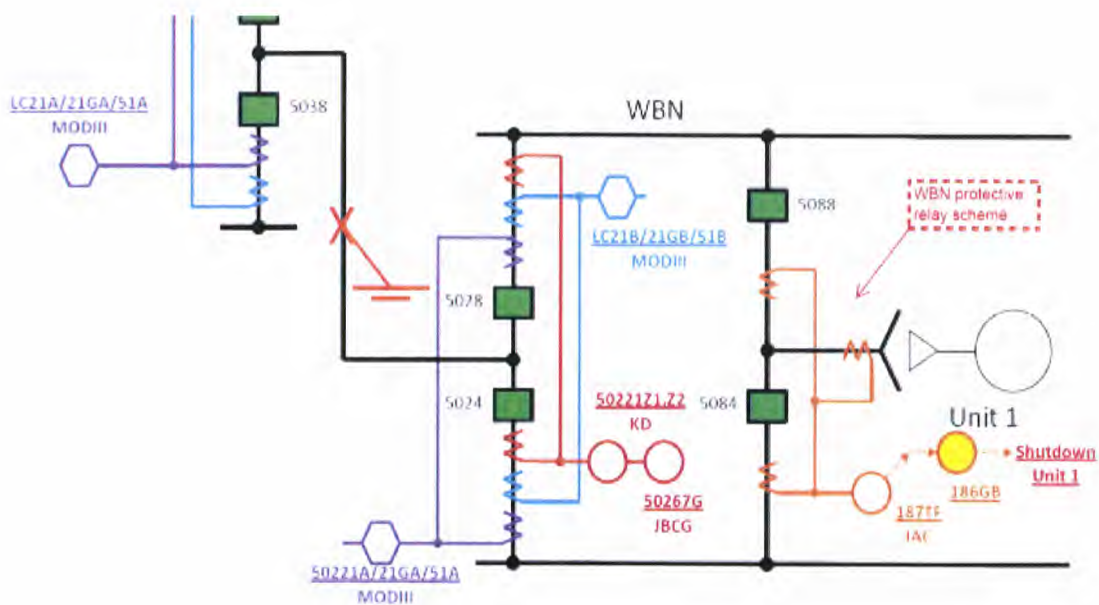
### Protective Relay Scheme

On June 28, 2013 at 13:29:45, an A-phase ground fault occurred on the Roane 500kV transmission line approximately 22 miles from WBN1. Concurrently (13 cycles later), WBN1 experienced a reactor trip due to the actuation of the 1A Main Bank Transformer Feeder Differential Relay (187TF) [Energy Industry Identification System (EIIS): RLY61]. The 500 kV transmission line fault was caused by a tree that fell onto the A-phase of the transmission line (schematic in Section V, Additional Information). The tree was cut by a local land owner.

The plant trip occurred when A-Phase protective differential relay 187TF received current above the actuation setpoint of 1.5 amperes (A) (i.e., registered a false fault in protected zone). The relay responded by actuating the 186GB relay [EIS: RLY94] resulting in a turbine trip. Since the reactor was above 50 percent power, the turbine trip resulted in an automatic reactor trip. When the main feedwater pumps tripped, an automatic start of all Auxiliary Feedwater (AFW) Pumps was initiated. There were no safety system failures that adversely affected technical specification parameters/conditions during this event. Post-trip review revealed that the event was not a scram with complications.

TVA conducted testing during the spring 2014 refueling outage which revealed the cause of the event was an incorrectly de-terminated current transformer neutral conductor which caused a differential relay imbalance in the summation circuit, during the faulted conditions.

The neutral conductor was re-terminated in accordance with design documents.
